FUTILITY AT THE UTILITY

**How use of the wrong answer key for safety tests
went undetected for 20 years at Fermi Unit 2**

**DAVID LOCHBAUM
DIRECTOR, NUCLEAR SAFETY PROJECT
FEBRUARY 2007**

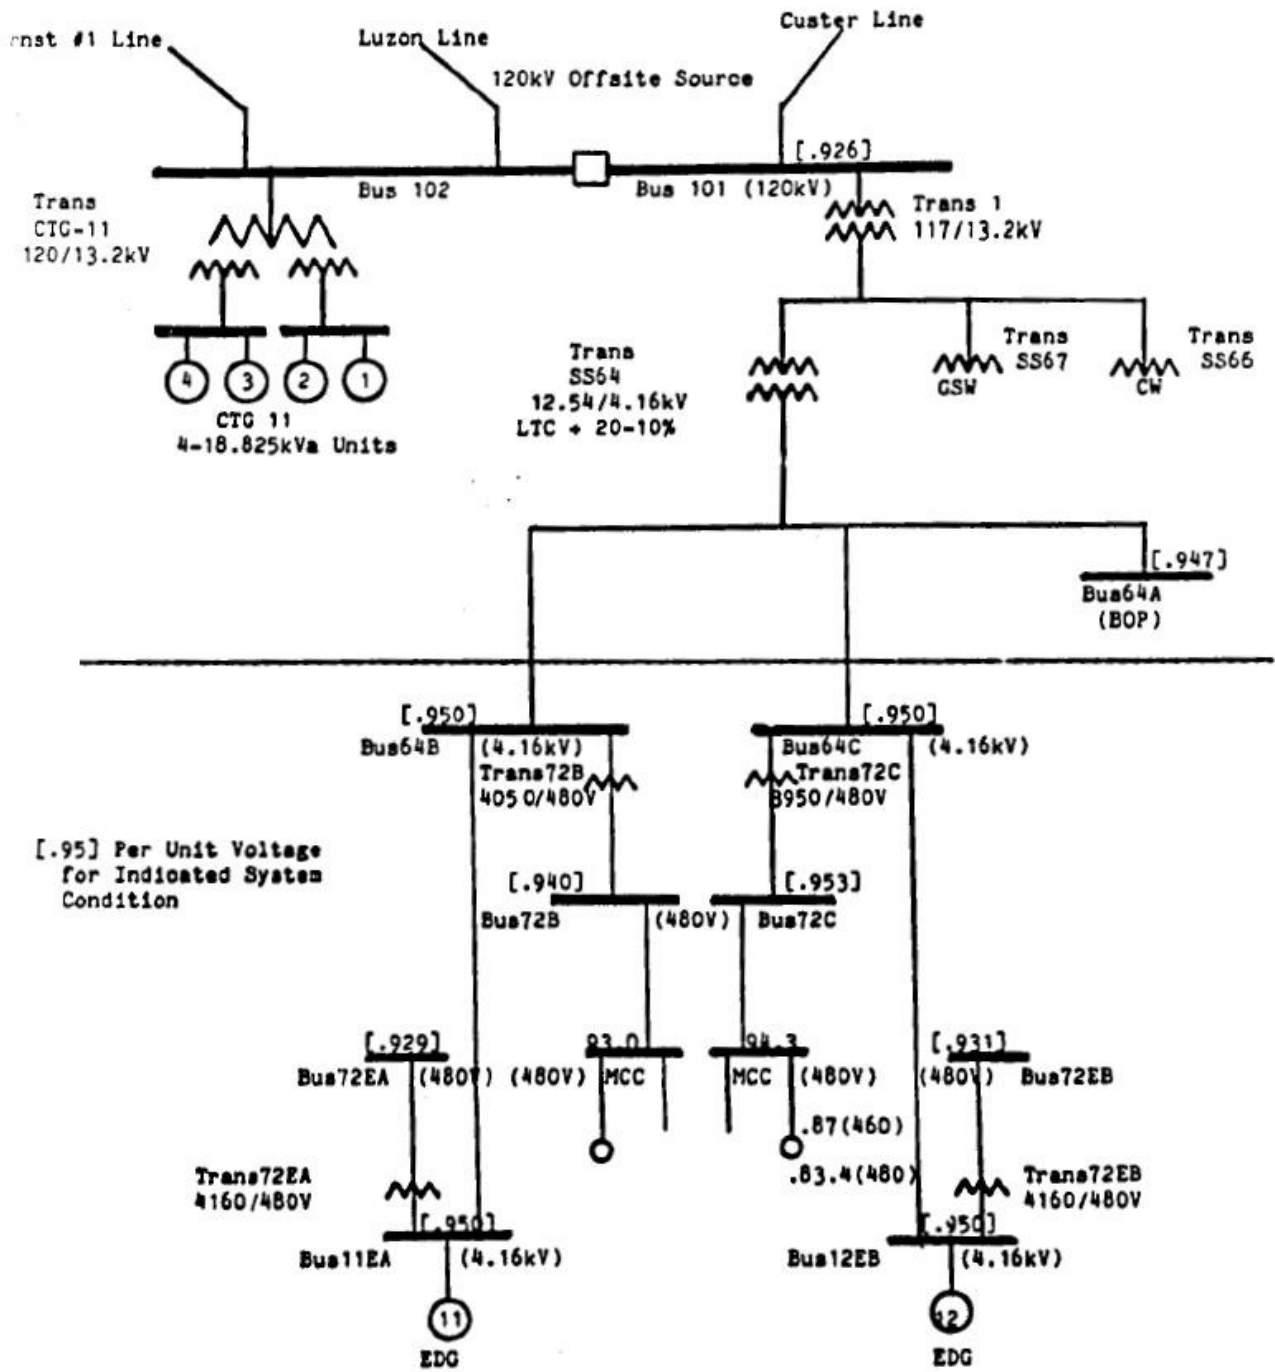
Schematic Diagram-Div I

Figure 1 provides a schematic diagram for one of the two safety-related divisions at Fermi Unit 2. The top portion of the diagram shows the plant's switchyard with the transmission lines connecting the plant to the electrical grid (i.e., the Luzon and Custer lines) along with some of the electrical distribution system for non-essential plant equipment (e.g., Transformer S566 provides electricity to the circulating water (CW) system pumps and equipment). Emergency diesel generators (EDGs) 11 and 12 are shown at the bottom of the diagram providing power to safety-related 4.16 kilovolt electrical buses 11EA and 12EB which in turn supply power to safety-related 480 volt electrical buses 72EA, 72EB, and motor-control centers (MCCs). MCCs are the nuclear plant equivalent to fuse panels in homes: they contain electrical breakers that control power supply to electrical circuits throughout the plant. Non-safety-related 4.16 kilovolt electrical buses 64B and 64C in the middle of the diagram show how the safety-related buses are normally powered from the electrical grid.

Date	Event
January 11, 2001	Specification 3.8.1. ⁸⁴ The NRC reported its inspectors had reviewed Modification 30458 that revised the Bus 64C undervoltage load shed scheme with no findings. ⁸⁵ UCS View: As indicated in Figure 1, Bus 64C is part of the Division 1 electrical distribution system which had the wrong undervoltage trip setpoint in its test procedure. So, there was a “finding” that NRC inspectors failed to make during review.
March 21, 2001	A few hours into the 23-hour endurance run of Emergency Diesel Generator 14, insufficient oil level in the reservoir caused the outboard bearing to overheat and catastrophically fail. ⁸⁶
April 18, 2002	The NRC reported its inspectors had reviewed Revision 47 to surveillance test procedure 24.307.15, “Emergency Diesel Generator 12 – Start and Load Test,” with no findings. ⁸⁷
February 6, 2003	During a test run of Emergency Diesel Generator 11, workers noticed that the exhaust temperature from cylinder 2 was about 100°F below the normal value. The unexpectedly low temperature was attributed to the fuel injector nozzle allowing more fuel oil to flow into the cylinder. The nozzle was sent back to the vendor who found that the torque on the spring that controlled fuel flow rate was set at 20 ft-lbs instead of the required 55 ft-lbs. Workers at Fermi Unit 2 determined that procedure 34.307.001 did not contain sufficient information to ensure the proper torque setting on the injector nozzle spring. ⁸⁸

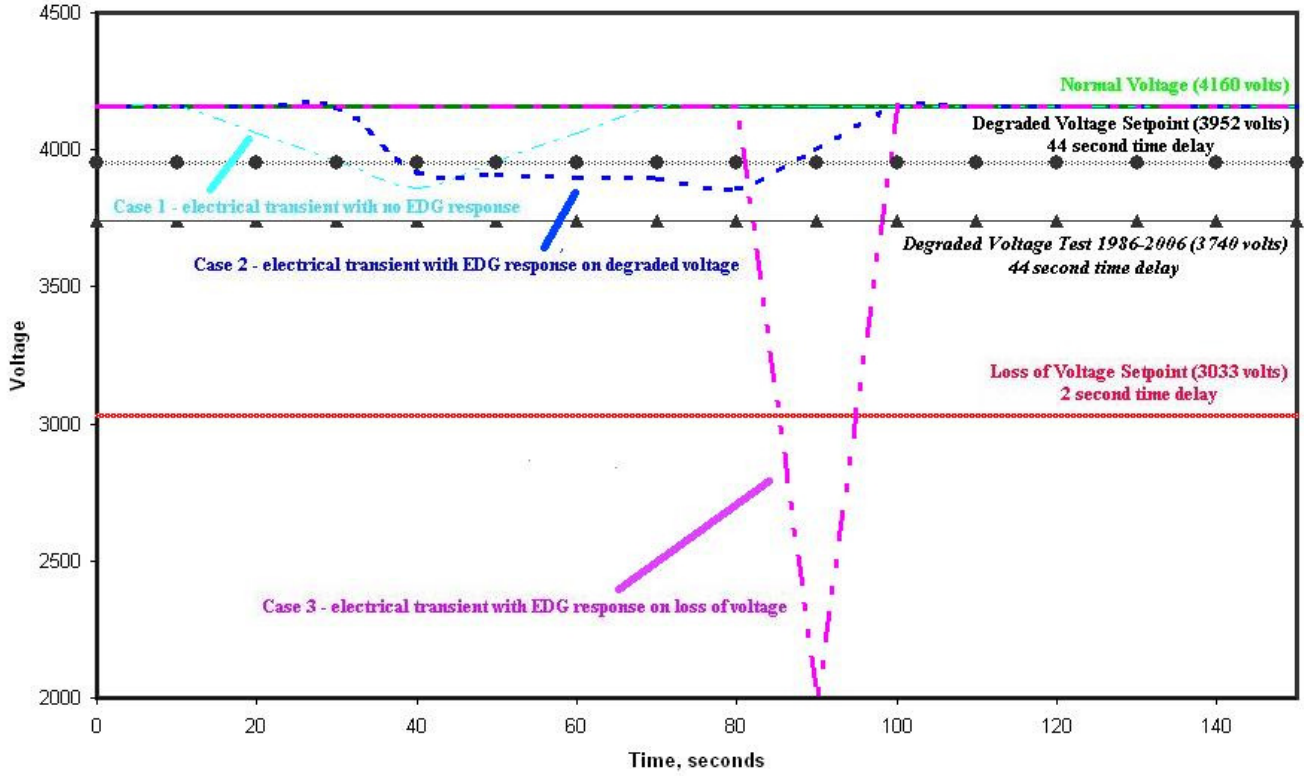
Electrical Bus Voltage Protection

Case 1 – Electrical transient with no EDG response: The electrical bus voltage drops below the degraded voltage setpoint of 3952 volts, starting the 44-second timer. But because the voltage returns to over 3952 volts in less than 44 seconds, no signal to start the emergency diesel generator occurs.

Case 2 – Electrical transient with EDG response on degraded voltage: The electrical bus voltage drops below the degraded voltage setpoint of 3952 volts, starting the 44-second timer. With voltage still below 3952 volts after 44 seconds, the emergency diesel generator is signaled to start. Power from the running emergency diesel generator restores the electrical bus voltage to its normal value.
