**Torus Coating Problem
at Fermi Unit 2
July 2019**

NRC Launches Special Inspection at Fermi Nuclear Power Plant

On July 11, 2019, the Nuclear Regulatory Commission (NRC) announced it was sending a Special Inspection Team to investigate degradation of a coating applied to the interior surface of the torus.

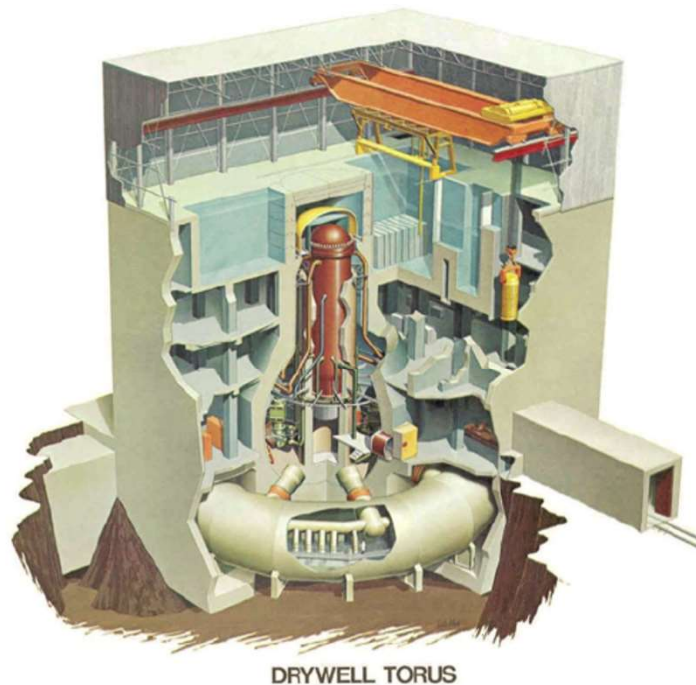
During a recent engineering inspection, the NRC noted a degradation in the paint inside the torus, a donut-shaped component of the reactor containment located below the reactor vessel. Filled with water, the torus is designed to absorb energy from the reactor or supply water to safety systems during an accident. Loose paint chips from the torus could potentially impede the flow of water to safety-related equipment.

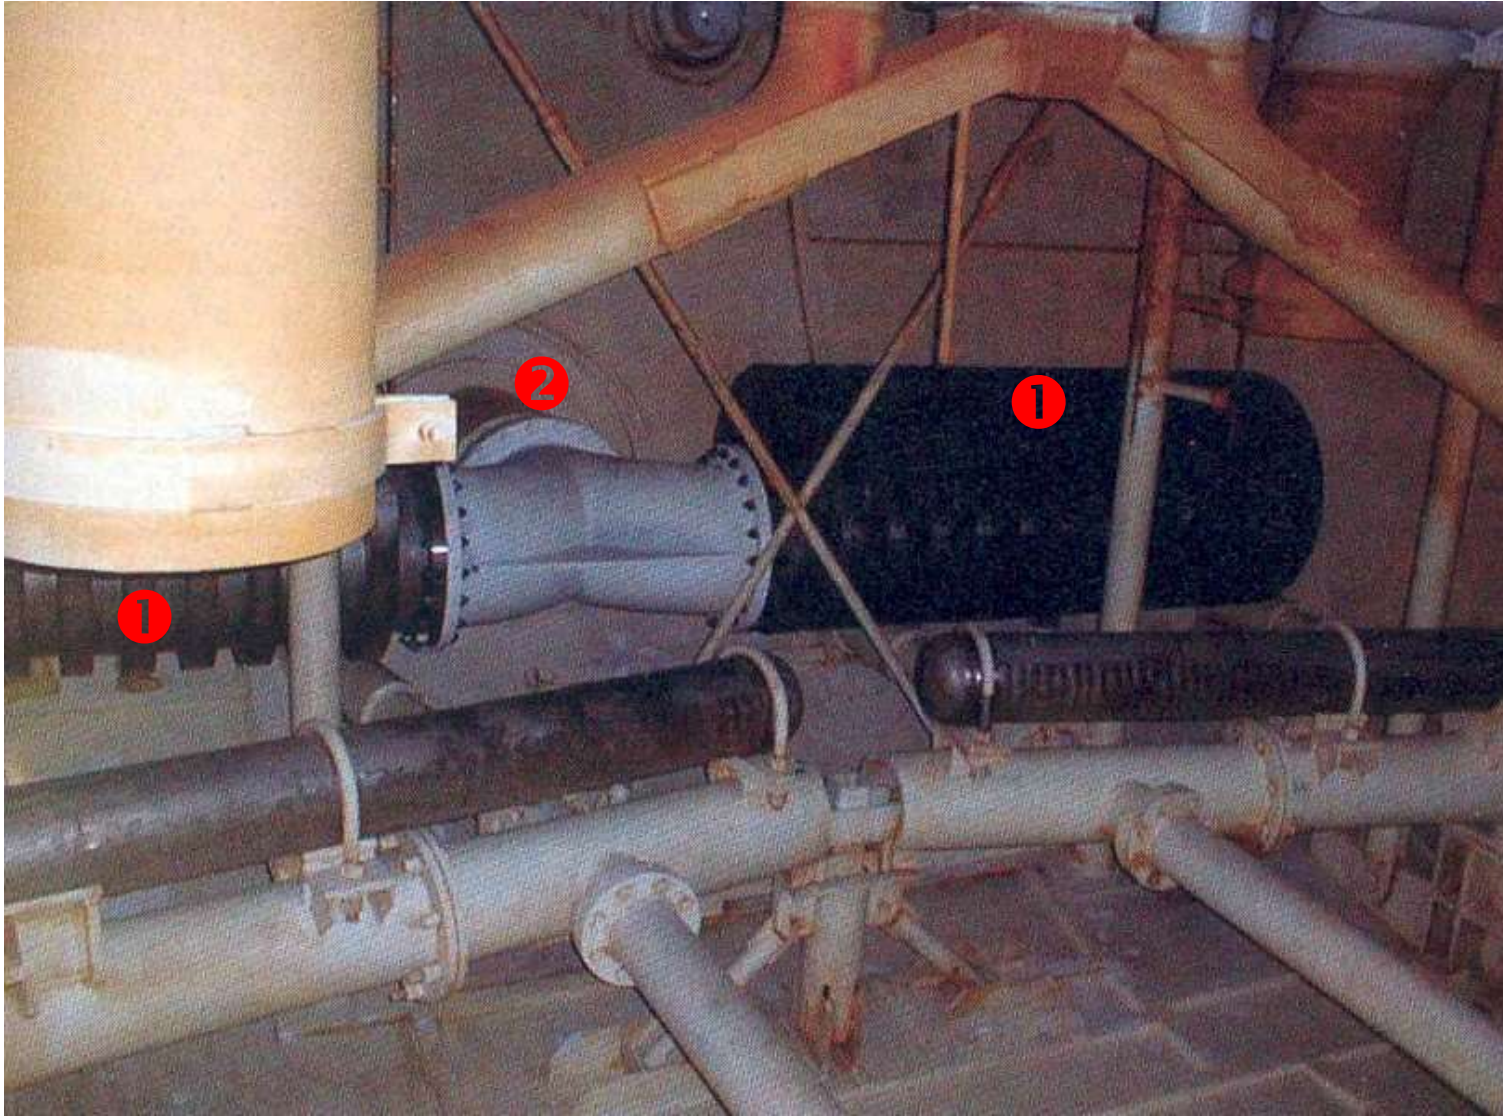
This picture taken inside a torus drained of water shows larger strainers (1) attached to a pipe penetrating the torus wall (2) to supply water to emergency pump(s).
